# 2007 ANNUAL INSPECTION, MONITORING AND MAINTENANCE REPORT 1 ½ MILE REMOVAL REACH GENERAL ELECTRIC (GE)/HOUSATONIC RIVER SITE Environmental Remediation Contract GE/Housatonic River Project Pittsfield, Massachusetts

DCN: GE-010808-ADSO

January 2008

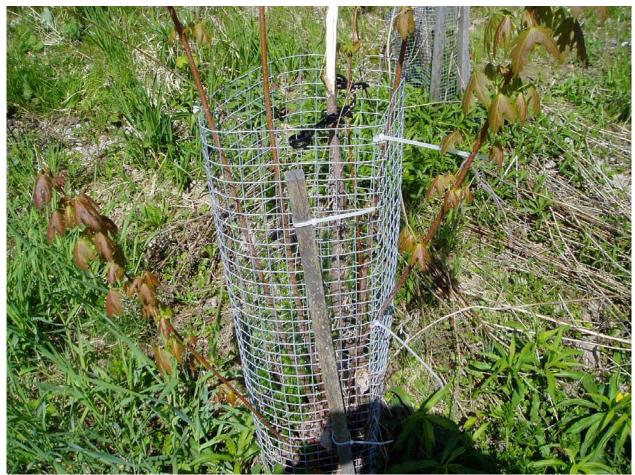
Photo 1. Silver maple requiring pruning due to lateral branching through protective cage.

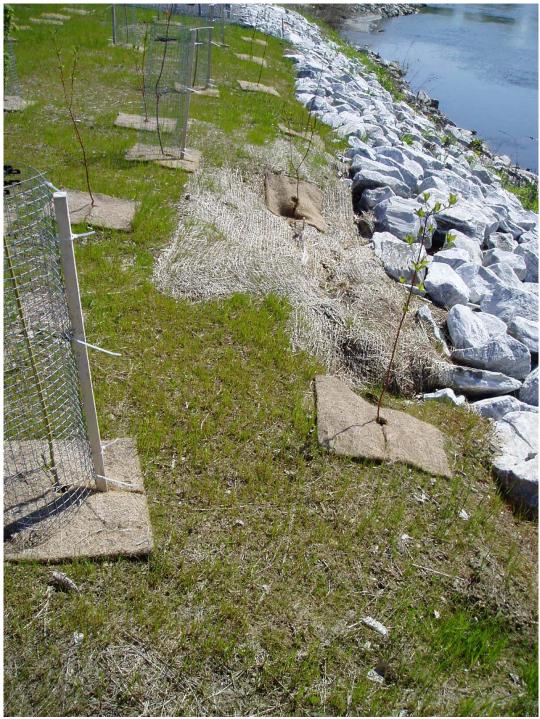
Photo 2. Erosion under erosion control mat on west bank south of Lyman Street.

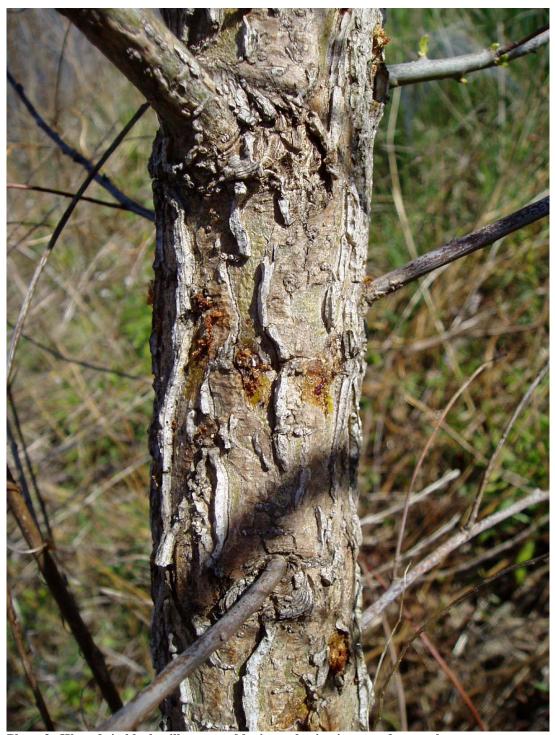
Photo 3. Wounds in black willow caused by insect boring into woody growth.

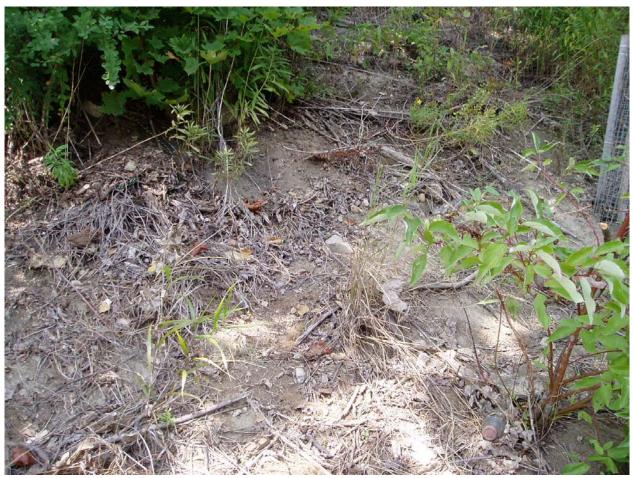
Photo 1. Bare soil recommended for re-seeding in monitoring plot 2-W-1.

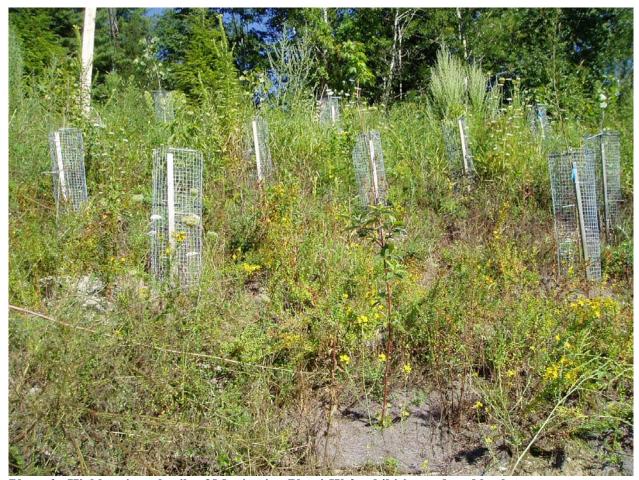
Photo 2. Highly mineral soils of Monitoring Plot 4-W-2 exhibiting reduced herbaceous cover.

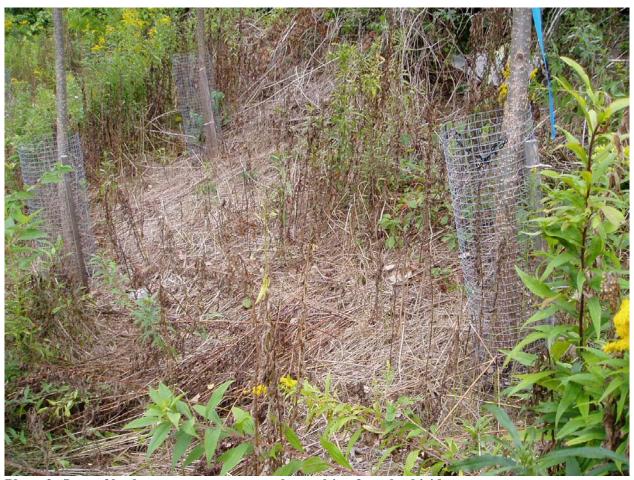
Photo 3. Loss of herbaceous cover apparently resulting from herbicide treatment.

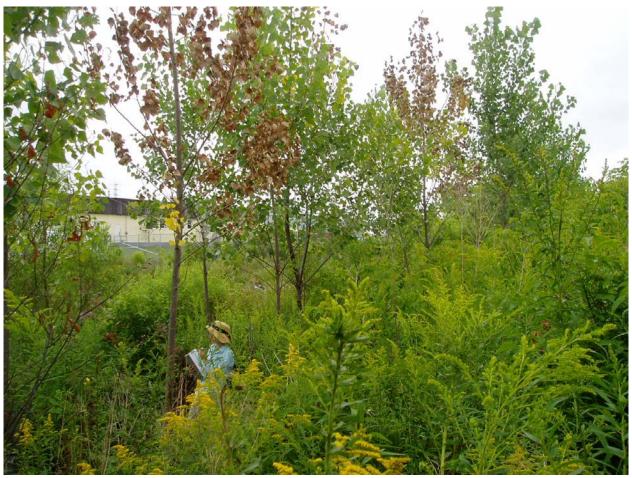
Photo 4. Eastern cottonwood trees apparently stressed by herbicide exposure.

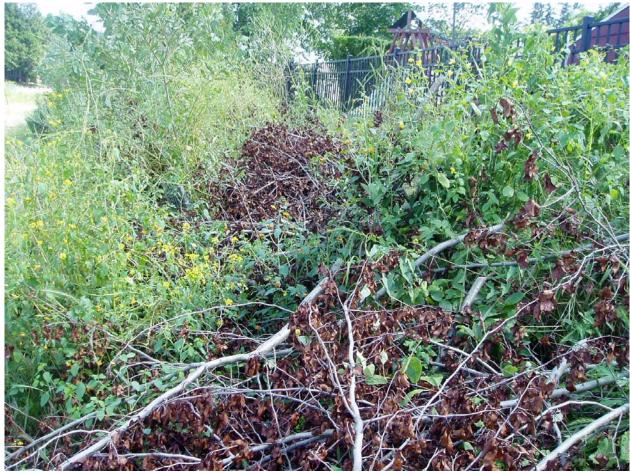
Four shrubs within monitoring plot 4-W-3 were apparently mowed by the property owner. Shrub density within this plot is still exceeds the performance standard. Lawn debris was observed to have been deposited on tree and shrub plantings behind a private residence between monitoring plots 3-W-2 and 3-W-3.

Photo 5. Lawn debris placed on planted trees and shrubs behind private residence.

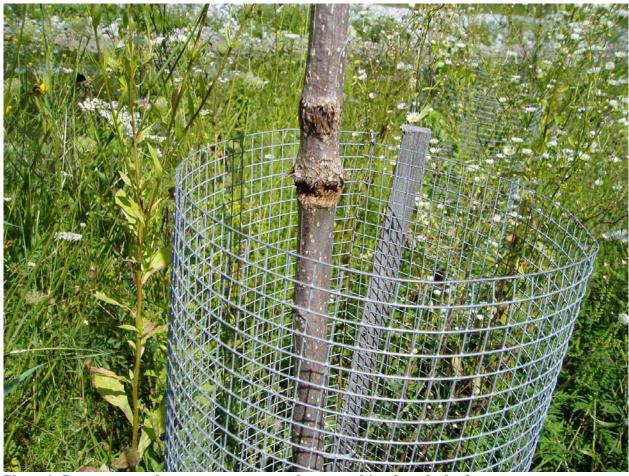
Photo 6. Damage caused to eastern cottonwood tree resulting from lack of tree protector.

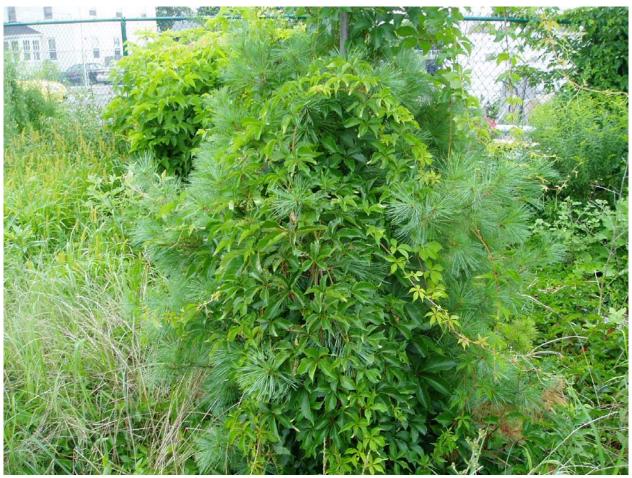
In general all trees and shrubs appeared healthy and to be growing vigorously. On Parcel I8-24-1 several invasive species were noted and need to be controlled. Virginia creeper (*Parthenocissus quinquefolia*) was observed to be climbing on one white pine and should be removed by hand from this tree. Hedge bindweed was observed to be growing on one balsam fir (*Abies balsamea*)

Photo 7. Virginia creeper climbing on white pine in upland planting area adjacent to Harry's Supermarket.

- Remove by hand Virginia creeper from one white pine and hedge bind-weed from one balsam fir on Parcel I8-24-1 (Harry's Supermarket)
- Control invasive species (i.e., Japanese knotweed, black locust, and purple loosestrife) observed within Parcel I8-24-1 (Harry's Supermarket).
- Plant 2 red maple (*Acer rubrum*) on Parcel I6-1-66 to replace the dead white birch

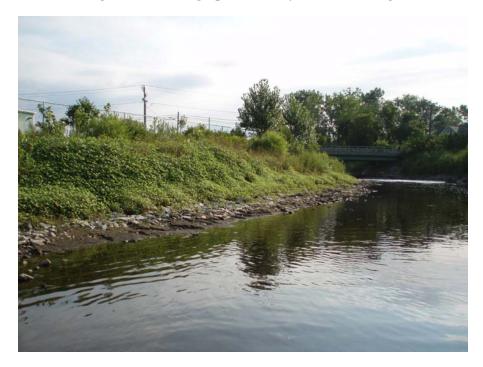
Minimal exposure of sheetpile was observed along the east riverbank adjacent to the carwash facility on Parcel I8-23-6 and along the west bank adjacent to Parcel I7-21-3. The same exposure was also noted in previous inspections in 2006 and after the high flow event in April 2007. The observed sheetpile exposure was less than 6 inches in depth and the extent of the aforementioned area was less than approximately 10 feet in length. No action other than continued observation is recommended at this time

Photo 3: Area of Sheet Pile Exposure, Monitoring Area 1, Left Streambank

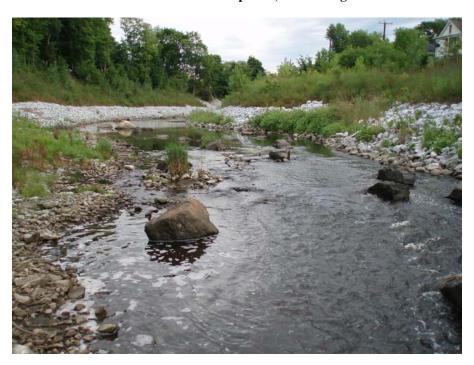
Photo 6: Area of GeoWeb Exposure, Monitoring Area 2 Right Streambank

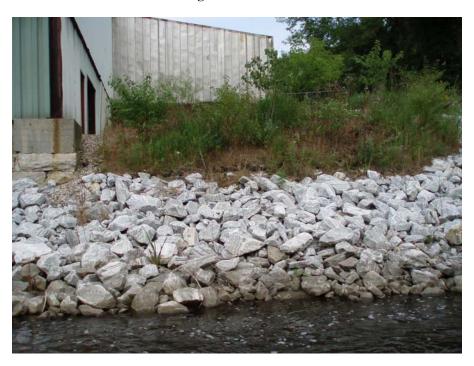
Photo 7: Sediment Material, Monitoring Area 3 Right Bank Looking Upstream at Dawes Avenue Bridge

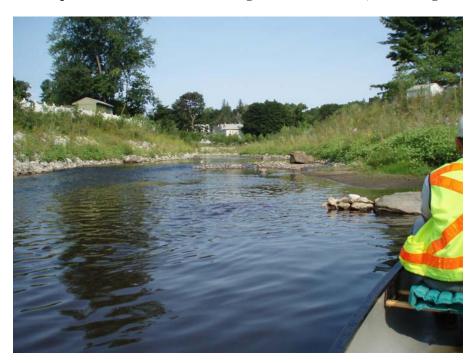
Photo 9: Scour Adjacent to Culvert Discharge Left Abutment of Pomeroy Avenue Bridge
